Improving heat rate by input/loss monitoring

By David Rodgers, PE, and Dean Mason, Portland General Electric Co.

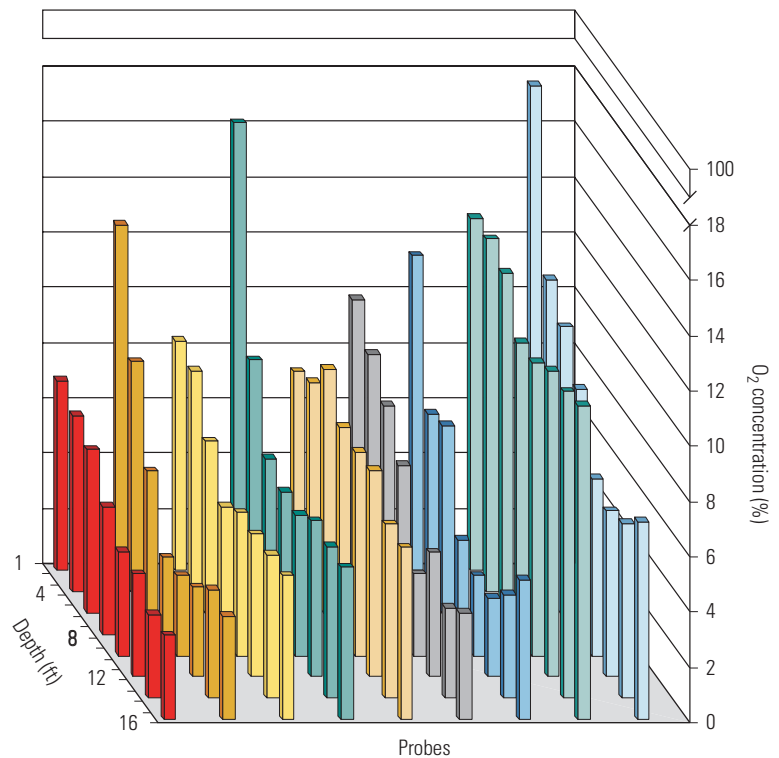
An independent lab was hired to create a top-to-bottom, side-to-side O₂ profile of the boiler exit flue. Results of these measurements are shown in Figure 2. Boardman's stack has two ducts, and testing consisted of measuring O₂ on two 40-point traverses of the entire exit flue. The results showed significant stratification and many higher-than-expected O₂ readings—although the 14 O₂ probes in the ducts continued to indicate that O₂ concentrations were averaging just 2.8%.

What could be responsible for the discrepancy? A poor design, as it turned out. Within the boiler's exit flue, seven of the O₂ probes were mounted at the 6-foot level; the other seven were at the 12-foot level, in a 22-foot-deep duct. The locations of the O₂ probes tended to bias average readings in favor of the front burners. Due to the stratification of the gas flow and the fact that there were no O₂ probes in the bottom of the duct, burners on the back wall of the boiler were not "seen," so the amount of excess air they were releasing was not being measured. Inadequately isolated out-of-service burners only exacerbated the problem.

2. Before. The O₂ profile of the boiler exit flue prior to instrumentation and hardware modifications showed significant stratification and many higher-than-expected O₂ readings. Source: Portland General Electric

With the information from the traverse of the exit flue and the performance-testing results, the plant elected to modify all 32 sleeve dampers (to enable them to be completely isolated) and move the 14 existing O₂ probes. Plant engineers determined that to adequately monitor exit flue O₂ it would be necessary to place the probes to monitor at the centroids of equal areas in the duct. Doing that would require installation of 12 additional O₂ probes. Not knowing what the results would be, the plant decided to move the existing O₂ probes to monitor at the centroids of equal areas in the upper half of the

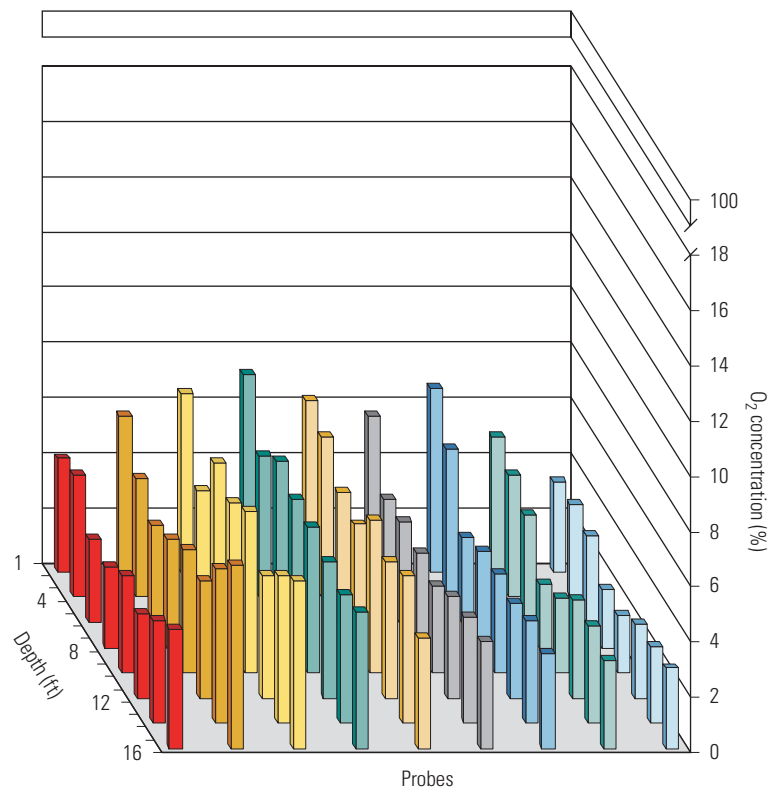
3. After. Post-modification measurements of exit flue O₂ show significantly lower levels. Source: Portland General Electric

The results of this modification were dramatic. Boiler efficiency rose from just over 83% to between 85% and 85.6% with the same fuel. Another traverse of the flue was completed (after the modifications) while controlling to an O₂ setpoint of 2.5% (Figure 3, page 39). Of course, these readings did not reflect a simple setpoint change but improved air leakage and improved controls. As further confirmation, CO₂ readings

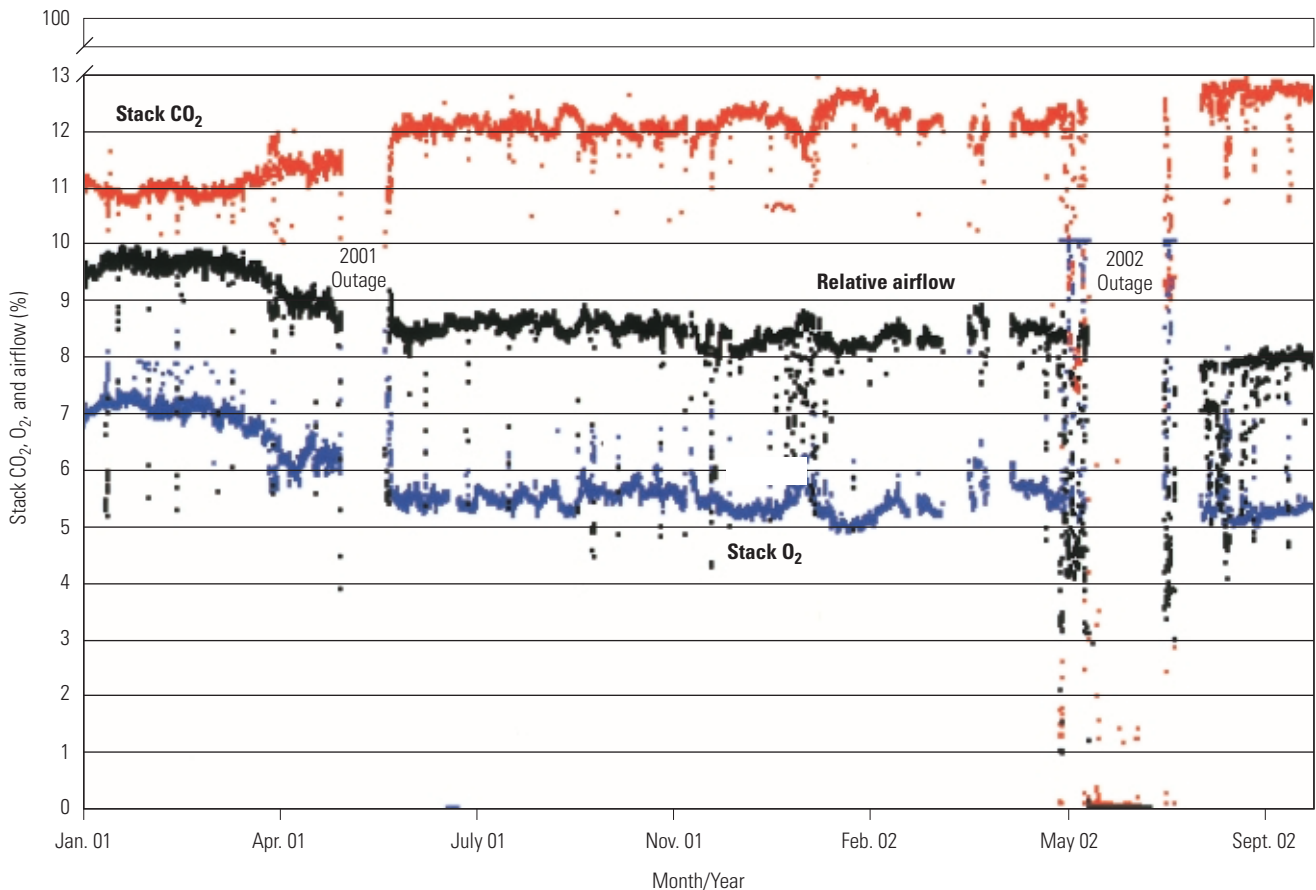
4. Reduced in-leakage. Enhanced air-leakage management and hardware upgrades demonstrate considerable improvement in boiler performance over time. CO₂ readings taken across Boardman's air preheaters indicate that air in-leakage was reduced from 20% to 5%. Source: Portland General Electric

Since the modifications, boiler efficiency has further improved by 0.5%, as shown in Figure 4. More than one year's worth of data shows the value of the instrumentation improvements made during the outages of 2001 and 2002. These are measured, "noncalculated" parameters that directly reflect plant performance.

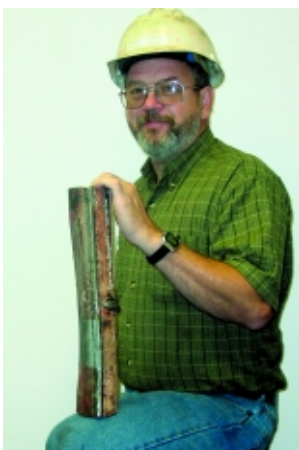
5. Slag dent. Randy Curtis, one of Boardman's plant engineers, holds a dented tube from the lower slope of the boiler. The dent was caused by a large mass of falling slag. Courtesy: Portland General Electric

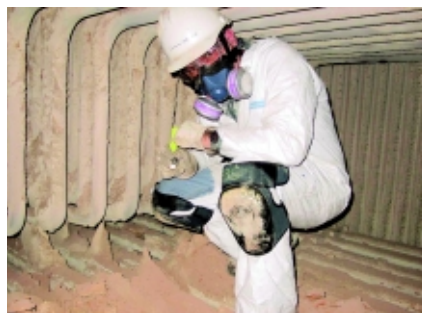
6. Dirty job. PRB coal has a greater tendency to slag than eastern coal, which increases the frequency and difficulty of boiler cleaning. Boardman Plant Manager Loren Mayer inspects the reheater section. Courtesy: Portland General Electric
